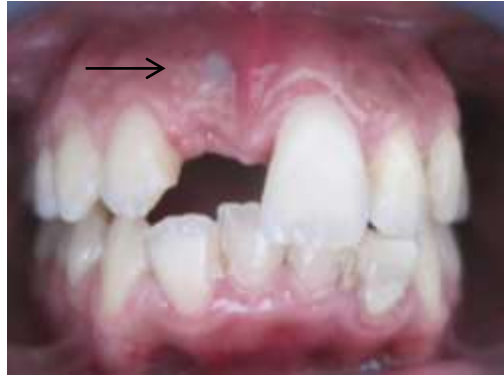
Figure 1. The implant on #11 was detected on buccal aspect (seen by arrow)
