PROTECTION AND REMEDY FOR CULTURAL HERITAGE BUILDINGS IN CHINESE TOURISM CITIES, WITH AUTHENTICITY AND MINIMAL INTERVENTION: A CASE STUDY OF ZHEJIANG AREA, CHINA

THE GENERAL INFORMATION OF QING-AN AND AN-LAN HALL

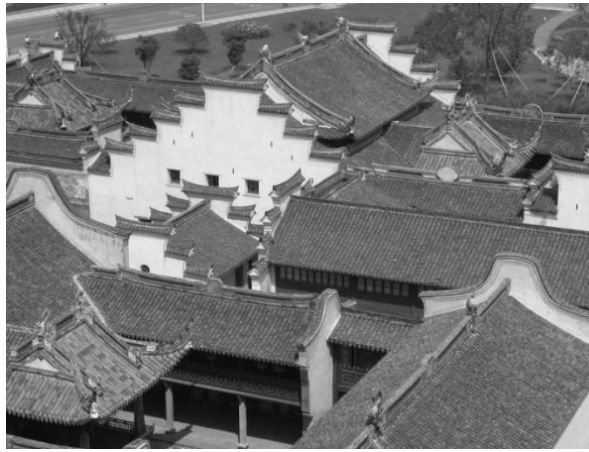
Figure1. Status quo of the Hall
Source: Taken by Team Members of Research Program

Qing-an and An-lan Hall, also known as "Yong Dong Tian Hou Palace," is commonly called Matsu Temple in Taiwan and Fujian. It is located at the east of the estuary of Fenghua River, Yong River and Yuyao River. Qing-an and An-lan Hall is a religious palace and a place for businessmen who are sailing on the sea to gather and entertain (Figure 1, Figure 2).

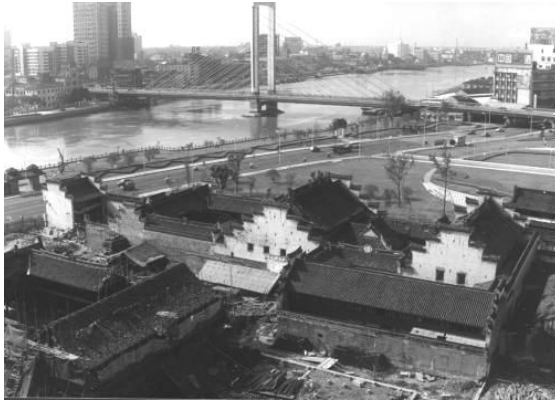
Figure 3. Former Look of the Hall

have collapsed. As to the less severe cases, such as the second lateral bays' roof and the vertical roof frame, most parts are decayed. Also the roof's leaking has caused the decay of rafter eaves (Figure 3). Through observation and study, the damage extent is so large that we have to combine the building with lifting beam brick-wood structure to ensure its safety. This structure requires main beams, on which short pillars hold up secondary beams, to hold up purlins during the construction. And secondary beams, on which short pillars hold up tertiary beams, hold up secondary purlins. The rest can be done in the same manner. Finally, ridge is held up by short pillars on tertiary beams.

Replace the ridge with three tiles drum roof of the same size, and entirely remedy the collapsed second lateral bay by making new hardwood purlins and cedarn rafters of 90cm diameter. Facing south, the building roofs are covered by small gray tiles. And their eaves are of a gentle slope, while their ridges are of a steep slope. Usage of large timber makes the roof looks beautiful, grand and decent (Figure 4).

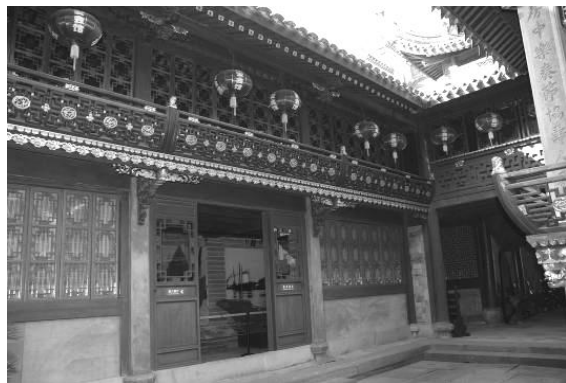
Figure 8. Doors & Windows: (a) Lantern Frame Style; (b) After Remedy

Through observation and study, it is confirmed that the original doors and windows of Qing-an and An-lan Hall site have missed. Thus, in order to recover and last the objective and real features of heritage buildings in history, society, science, technology and art, we should firstly take steps to excavate traces of the original details. Then use original technology to recreate the ancient hardwood wooden doors and windows basing on the historical records, among which six new ancient doors in size of 800cm * 2100cm and four ancient windows in size of 1200cm * 1500cm are to be made according to the two projects shown in Figure 8a. And the remedied door and window patterns are shown in Figure 8b. Take the construction technology of traditional window as an example: Template and staking-out → Production and assembly → wooden window frame installation → wooden window sashes installation → Painting.

- a. Template and staking-out: a plan of template and staking-out should be set out by experienced carpenter according to drawings of the ancient building, and high-quality dry wood should be reasonably selected.

- b. Production and assembly: high-level carpenters should be sent to do the processes such as sawing, planning and mortising in the carpentry workshop and to do the assembly according to the plan.

- c. Wooden window frame installation: install the wooden window frame around the reserved hole and do the anti-corrosion process in all junctions. Install the suspension wire and mark the elevation meeting the design requirements.

- d. Wooden window sash installation: When installing the sashes and sash glass, the glass should be fixed and marked as soon as it is located, and protection work should be done with the finished ones.

- e. Painting: paint the sashes and frames according to the design requirements, guarantee the high quality of painting to avoid peeling off, and ensure doors and windows well remain their ancient styles.

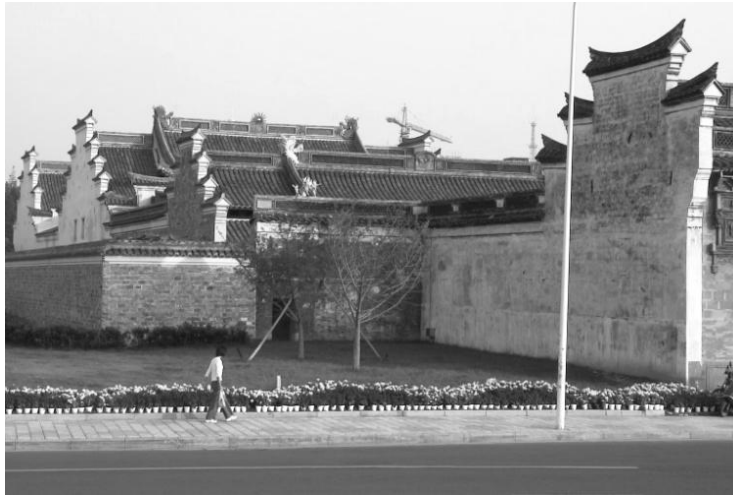
Figure 9. Collapsed Walls after Remedy

Tilt, crisp base, bulging and cracks imply the damage of walls. According to the extent of damage, measures such as the optional renovation, partial dismantling, partial patch and plastering should be taken. For instance, as for the collapse of the eastern wall of Qing-an and An-lan Hall, its remedy should be done base on the principle of the authenticity. The remedy should be done referring to the style, size and masonry technology of the surviving walls. Figure 9 is the Collapsed Walls after Remedy.

During the wall remedy, dismantling and building project often plays a role in the following situations: first, suffer from the broken brick walls, the degree of skew is equal to or greater than 8 cm. Taking the condition of hollowing into account, the area of the partial hollowing is equal to or great than 2 square meters, and the extent of bulge is equal to or greater than 5 cm; the hollowing makes the wall become two layers; the degree of skew is equal to or greater than 4 cm with crack accompanied; the thickness of lower and humid alkali is equal to or greater than 1/3 thickness of the wall; the width of crack is equal to 3 cm, while considering the cause of damage; second, suffer from the whole brick walls, the degree of skew is equal to or greater than 1/6 thickness or 1/10 height of the wall; the degree of brick sagging is equal to 1/10 length of the wall's span or the width of crack is greater than 0.5 cm. Other situations are the same with broken brick walls.

As for the walls of the building, as long as the new full bricks are used, the whitewash is rarely plastered. Almost every piece of brick can be seen extremely clear. Same as the wooden structure, bricks are not only an indispensable part of the structure, but also a decoration. As a result, they have rigorous and rounded rules. In view of the disordered specification of bricks and tiles in late Qing dynasty, the materials need to be selected and matched in associated with the local conditions.

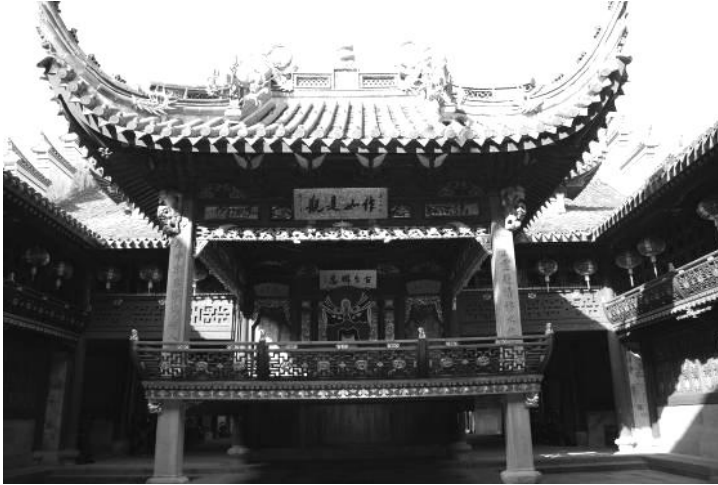
Figure 10. Theater Stage Roof after Remedy

Most black tiles in Qing-an and An-lan Hall have decayed by wind and rain, and most eaves tiles have fallen off. Some tiles even completely disappear as a result of beams’ collapse, which has been proved by part of tiles on eastern roof. Meanwhile, the breakage of tiles reduces the waterproof function of the roof, and rainwater seeps into the wooden components. Over many years, it results in decay, split and even break off, which endangers the using safety of the building. (Zhao *et.al*, 2005) The refurbishment project of roofs is on the basis of the actual situation of the roof tiles’ serious damage. After replacing by the Ø90cm cedarn rafters, the shedthinstile of 12cm thickness on roof bases, the waterproof linoleum layers, the battens and the grout of 50cm thickness are all need to be rebuilt, and then pave the small black tiles in a traditional way. Remedied roofs are shown in Figure 10 and 11. In the replacement of components, please preserve the original materials as much as possible, and make use of the original black tiles of better quality as small tiles for repaving (Zhao *et.al*, 2005), which interpret the authenticity and achieve the goal that “remedy a thing as it is”.

value of historic building can be extended permanently, it is essential to attach importance to the quality of the roof's selective remedy. In terms of remedying roof, more attention should be paid to weeding, cleaning the roof drains and patching the leakage.
